Dairy Farmer Dies 15 Days After All-Terrain Vehicle Rolled Over Him

SUMMARY

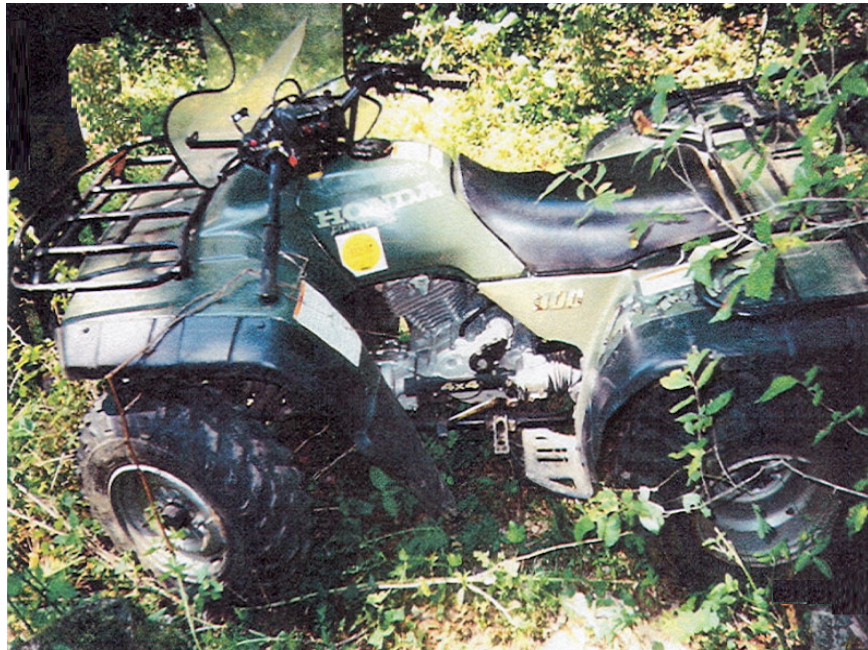
Figure 1. The ATV involved in the incident.

Around 9:00 a.m., the victim finished checking on the cattle in the pasture and had fixed the fence. He was driving his ATV down a hill back in the woods in his pasture, using the track that the loggers used a few years ago. He told his family he was just "crawling" in the ATV on the trail because this trail had branches and tree stumps on it. He stated that he had driven around some brush and then tried to drive over a small tree that was growing out of a stump. He thought it would smash down under the tires of the Honda, but it didn't and the ATV slowly tipped, causing him to fall down a 20-foot embankment ahead of the ATV. The ATV followed him down the embankment and came down on top of him and bounced off, causing multiple injuries. The victim had a cut on his head. He was not wearing a helmet. He thought he hit a rock or boulder that broke his ribs. He reported that he was "out" for awhile. He determined he couldn't jump when the ATV began to tip because he knew the embankment was there. He thought he would land on his feet before he got to the embankment, but instead he was thrown off as the ATV tipped. Many of the victim's injuries were on the left side of his body and the left handle bar on the ATV was bent.

Recommendation #2: Farmers and other employers should select an off-road utility vehicle equipped with ROPS and a seatbelt and designed to be used for work, rather than an all-terrain vehicle.

Discussion: In this incident, the victim was operating a four-wheel ATV. Farmers and employers should consider using an off-road utility vehicle. Some utility vehicles come equipped with a ROPS and seat belt and these may be better choices for agricultural use. Off-road utility vehicles are larger, wider and longer than an ATV, so they are less likely to tip over and if they would tip over, the ROPS and seatbelt may prevent a serious injury.
